Old Chiswick Conservation Area

Historic Walls Survey, Analysis and Conservation Advice

For The Old Chiswick Protection Society

September 2021

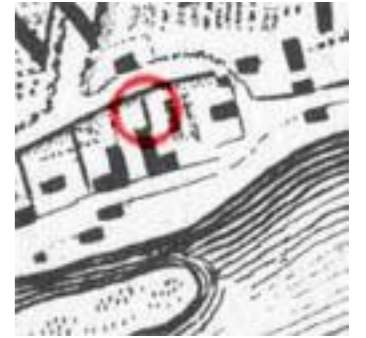
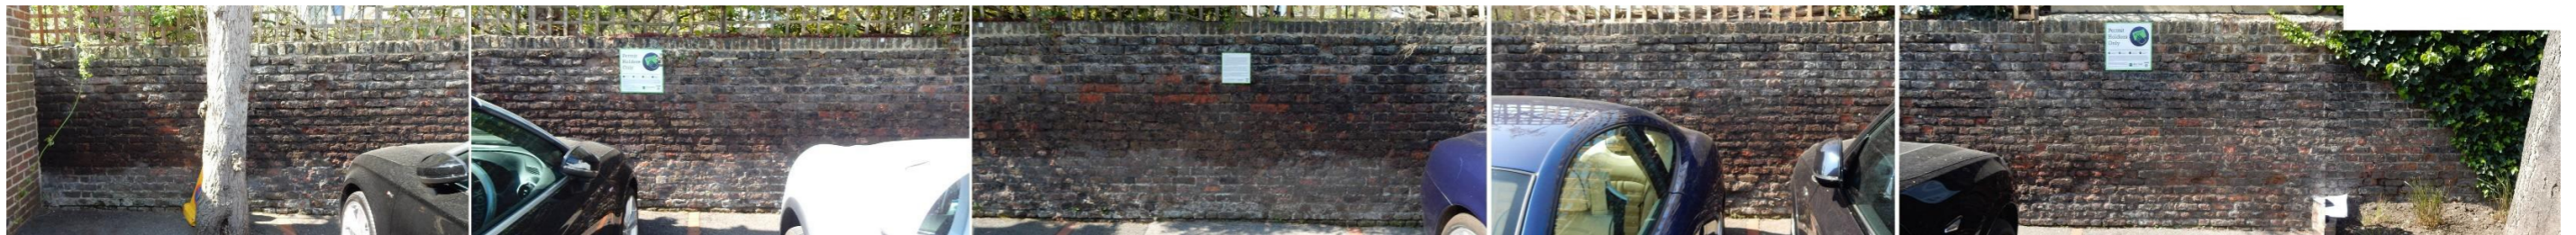
1.5.1 Miller’s Court/Swan House

Broadly consistent Flemish bond, although some areas of header courses at the base of the wall. 22-24 courses plus on-edge coping. Averaged brick dimensions 221 x 102 x 65mm. Colour: dark red/purple fire skin with mid-red body. Overall darkened by considerable dirt and soot accretions to bricks and surface of the pointing mortar. A piece of clay pipe was found embedded in one of the joints. Wall is consistently damp, and displays clear salt efflorescence to 30-90cm height on both sides. The position appears to tally with the N-S wall shown in Roque’s mapping, and the brick colour, composition, form and mortar would support an early 18th century date.

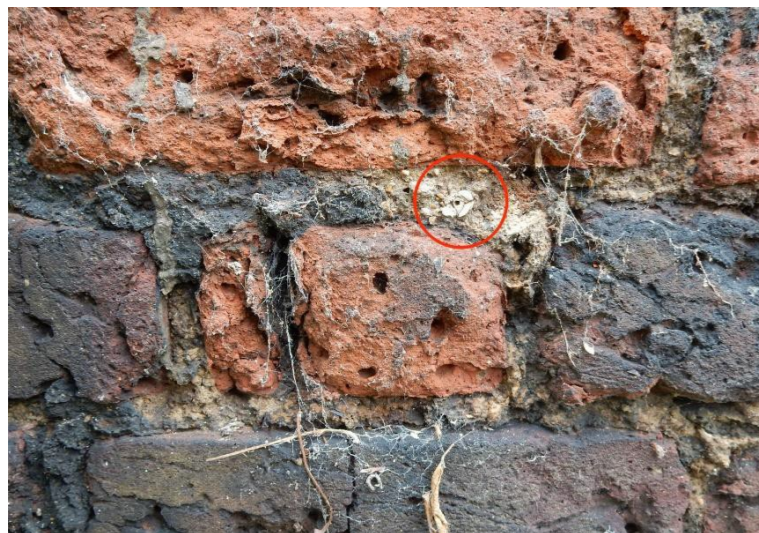
Clay pipe embedded in construction mortar (circled in red)

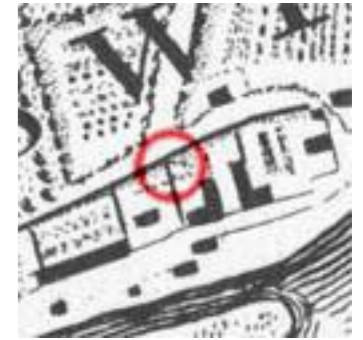
1.5.2 St John's House/Chiswick Lodge

Only the northern end of the wall bordering the Chiswick Lodge development was inspected. 35 courses plus on-edge coping. Lower 20 courses roughly English bond, and colours pale orange to dark red with sooty mortar. Upper courses in Flemish bond in brown brick, courses 21-28 with pale lime-rich mortar, modern straw repointing mortar to top, probably contemporary with structural restraint plates and ties. Brick dimensions not taken. The position of this wall appears to tally with that shown in Rocque's map, perpendicular to the long boundary wall along the south of Netheravon Road, this section now lost, and both brick composition and pointing appear similar to that at the rear of Morton House (see 1.5.3 below)

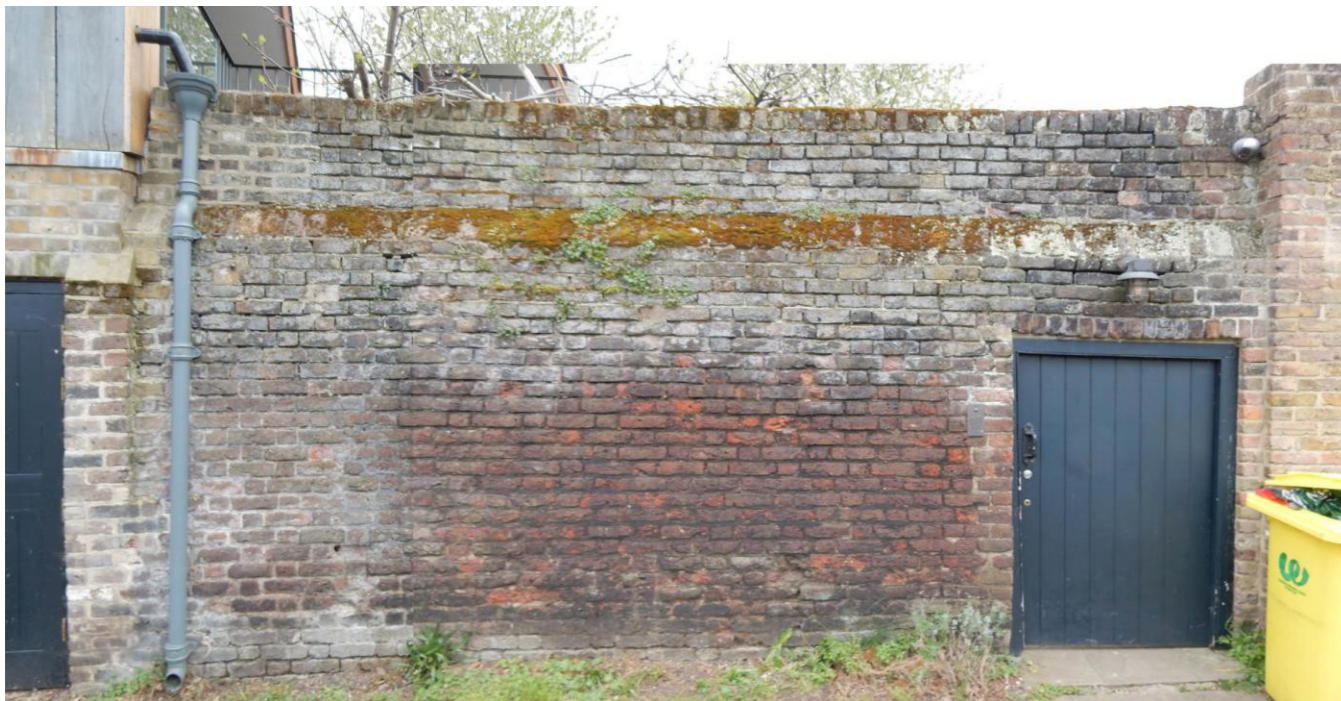
Northern boundary wall to Netheravon Road South:

Broadly Flemish bond, 28 courses to raked bricks on end, then six courses plus on-edge coping above. Colours range from blackened red to bright orange where the fire skin has been spalled or eroded. Sooty pointing mortar. The appearance of this wall is remarkably similar to that east of Orchard House (1.5.7). Bricks in the upper half with heavy pale salt efflorescence, mosses and vegetation. The doorway with early brick on edge lintel supported by the frame – this has dropped. Brick jambs have been reconstructed, and the right side has been rebuilt along with an adjacent pier in C20. The later upper sections of wall are in poor condition and require repointing to minimize water penetration and further invasive flora.

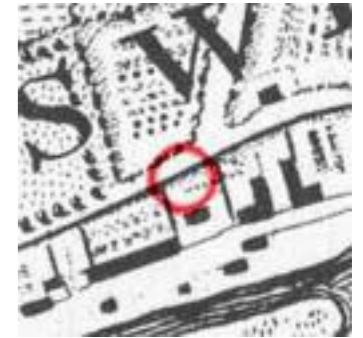
Eastern boundary wall:

26 courses up to a brick-on-edge coping, laid in Flemish bond, erratic in places. The bricks are soft red, laid in a lime-rich mortar which is pale buff in colour with varied aggregate size.

There are numerous areas of historic and more recent repair and replacement of sections of the wall. The main part is consistent in fabric and workmanship with the back, north wall, and corresponds with the position shown on Rocque's map suggesting this wall is of early 18th century construction or earlier. There are various areas of hard cementitious render, mostly in thin layers which is flaking off. The soft brickwork behind would benefit from removal by hand of any loose, friable or flaking render or repointing, and open joints repointed in lime mortar.

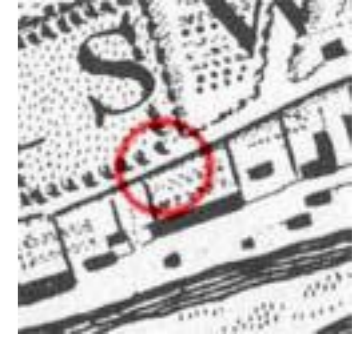
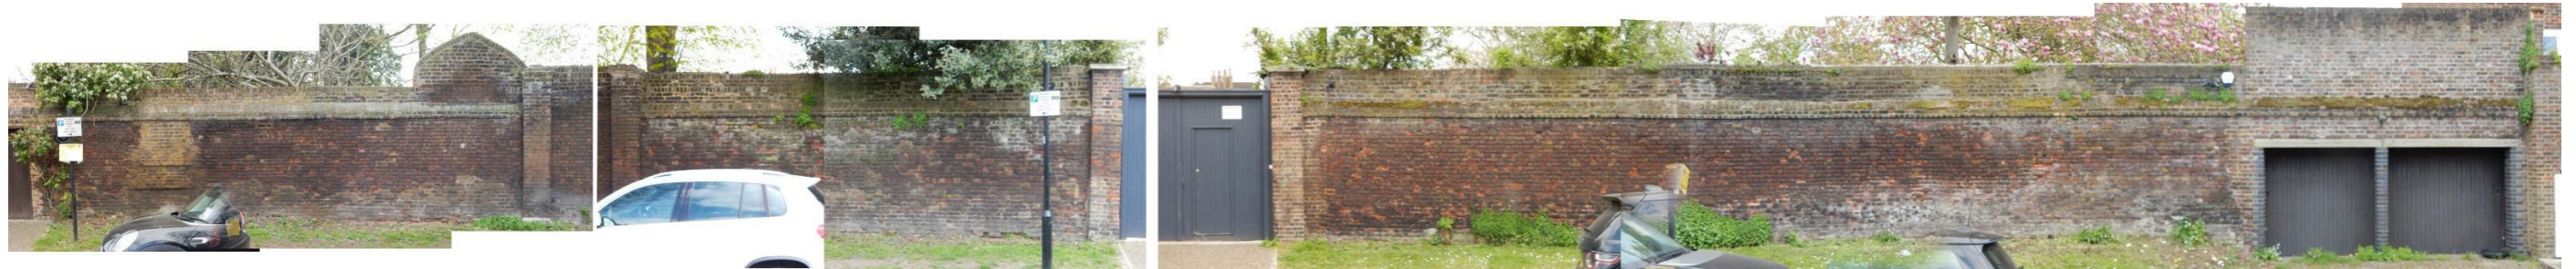
1.5.4 Walpole House

The north boundary wall (on Netheravon Road South) is listed in its own right (HE list entry number 1080317), and mostly contemporaneous with the principal phase of Walpole House, though recorded as a continuation of the boundary of the Prebendal Manor (c.1562) – see sections 1.5.7 to 1.5.8. The wall is formed of soft red bricks, laid predominantly Flemish bond, with large areas showing a dark sooty lime mortar. Towards the east end a section extended above the tapered capping is in the form of a narrow 4-centre arched gable end, adjacent to a pair of piers or buttresses with an infilled panel between. There is a pronounced inward lean through this east section of wall which may in time require structural intervention, and some invasive flora should be removed from the upper sections, and open joints repointed to prevent further deterioration.

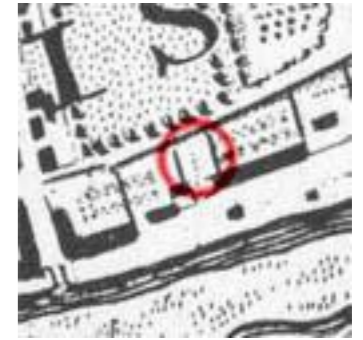
1.5.5 Eyot Green/Greenash and Mulberry Cottage

Walls bordering Greenash/Mulberry Cottage to the west were inspected from one of the Eyot Green properties. The boundary wall has a full height of 34 courses, consisting: of the earliest brickwork of first 16 courses, plus 2 projecting courses up to a clay tile coping, all in soft red bricks (with heavy dirt accretion and salt efflorescence), erratic bonding, but lowest courses more recognizably English bond with alternating stretcher and header courses. The upper section is modern construction of C20 multi-colour stock bricks with a cementitious mortar.

The position of the wall appears to tally with that shown in Roque's map, beyond the west of the Walpole Houseside boundary prior to the construction of the Tides, and the brick colour, form and composition appears earlier than the wall on the eastern boundary of the Eyot Green development, quite possibly early 18th century or before. The oldest sections of wall are heavily shaded and appear consistently damp, with some efflorescence visible, but are well protected by the angled coping bricks above. Any cracks, open joints or fissures should be pointed up in a soft lime mortar.

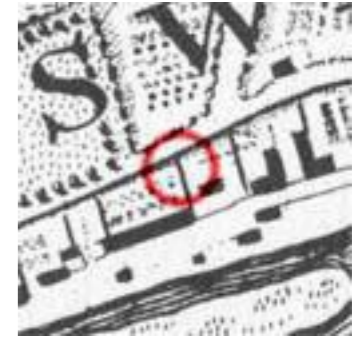
1.5.6 Chiswick Lodge parking/Osiers

This section of flank wall survives to the south of the recent development on the corner of Netheravon Road. It is currently the eastern boundary wall of the garden to Osiers, and may be the N-S wall shown to the east of the block comprising Walpole House and Strawberry House in the Rocque map.

The wall displays a similar brick colour and composition to the east wall of Swan House, and may also share an early 18th century date attribution. Various areas of cement pointing are visible in the wall but do not appear to be causing significant issues.

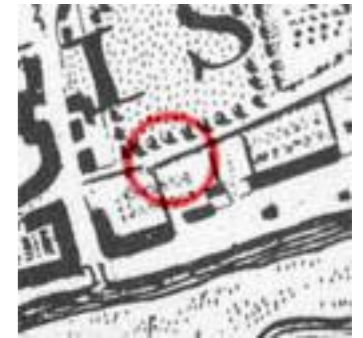
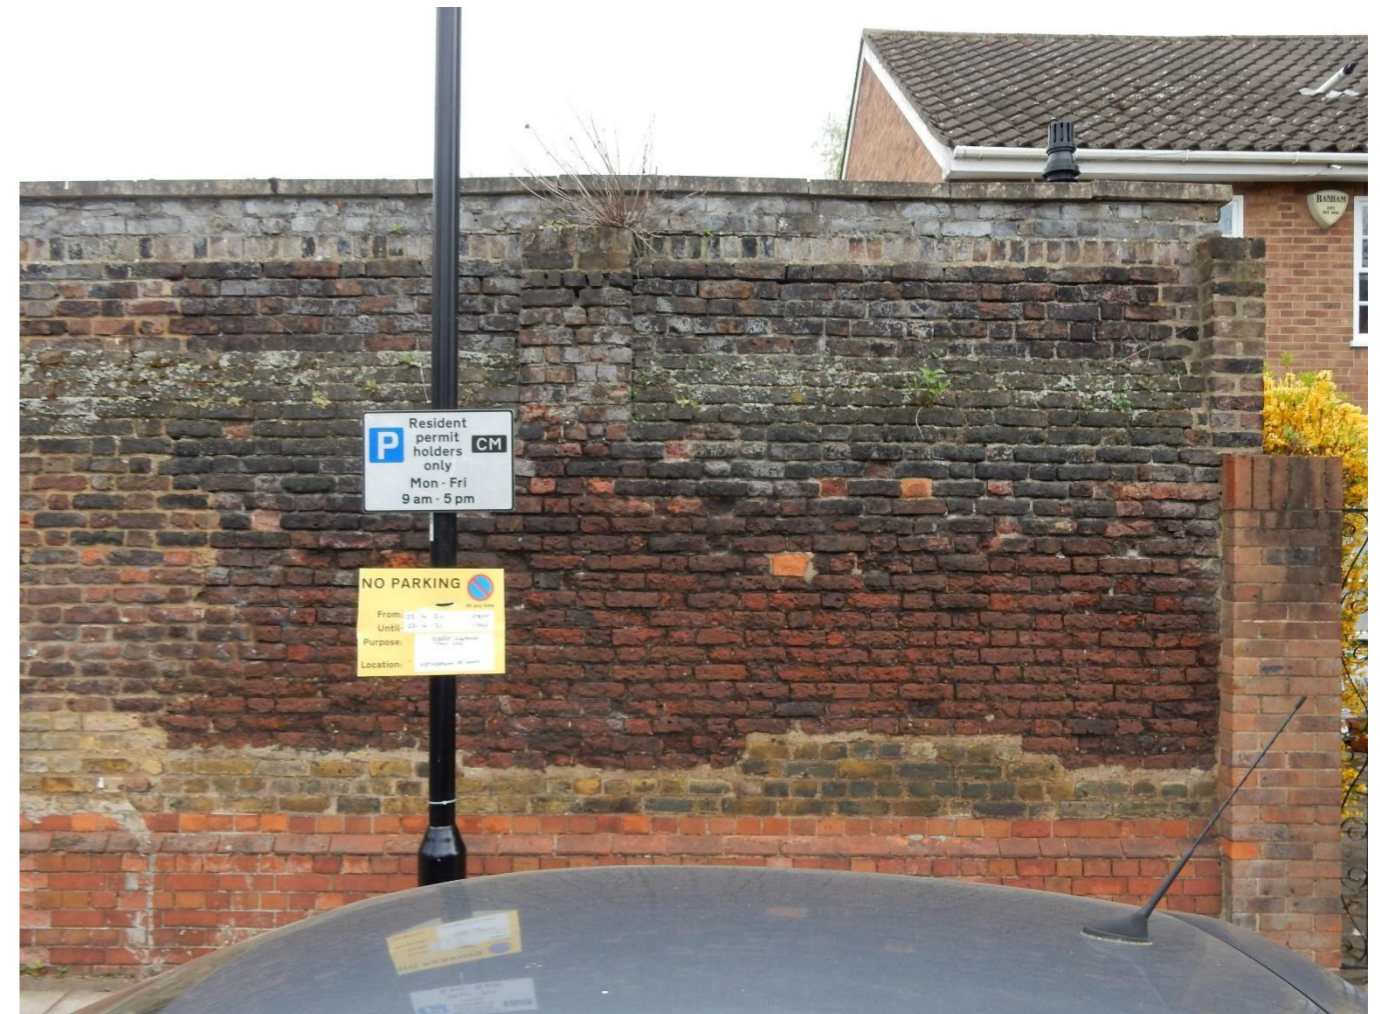
1.5.7 Netheravon Road, to east of The Orchard House

The brick form and colour in the central section of this wall is very similar to that in front of The Hollies, below (though not having acquired the dark purple of that wall, possibly being drier, or less subject to the capillary movement of soot from the blackened mortar). It therefore seems likely that this too is a section of the boundary of the Prebendal Manor. It does not presently appear to be listed.

As with its near neighbour, the lower portion of facings have been replaced due to losses from salt-accelerated decay, and the upper third up to coping, with battered section and buttress piers may be a later extension.

The wall is generally in better condition than its neighbour, but invasive flora should be removed and any open joints pointed up to prevent further deterioration.

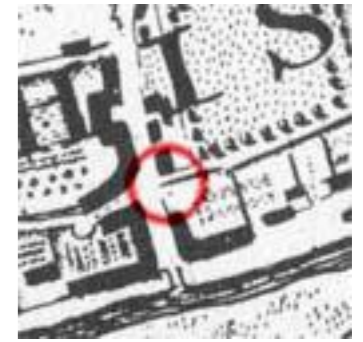
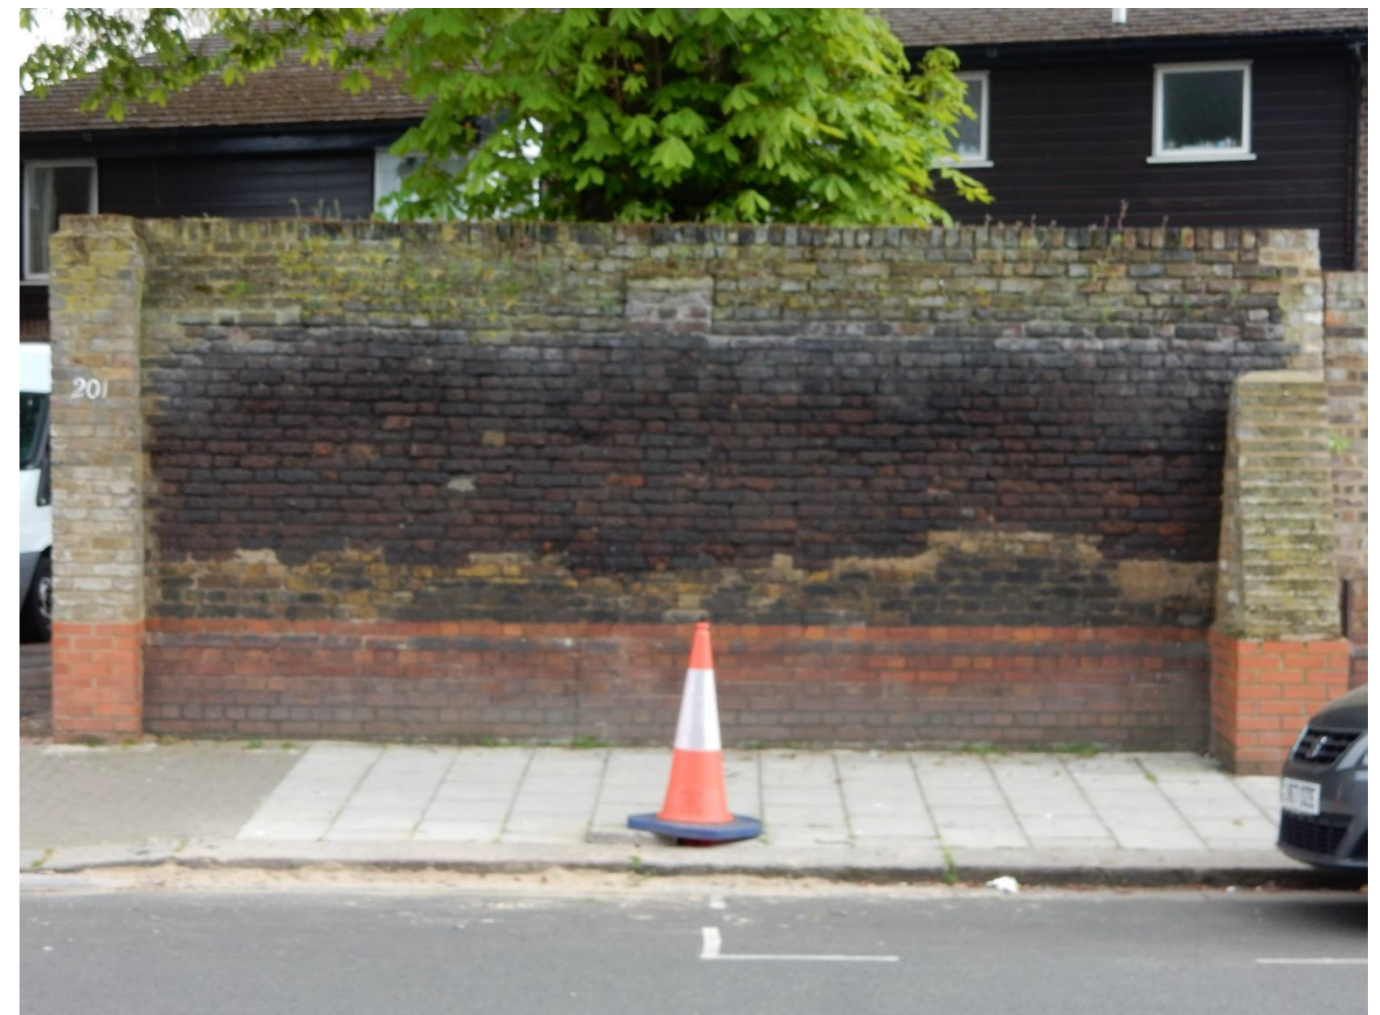
1.5.8 Netheravon Road South/201 and The Hollies

This section of wall, listed grade II (HE list entry number 1293992), is the remaining section of the northern boundary of the Prebendal Manor (of c.1562), later known as College House, the building having been replaced in 1710. Rocque's map suggests an enclosed building on this position by the mid-18th century, which may have incorporated this section of wall. The western end of the wall collapsed in 2018 during works to extend The Hollies. A modern brick pier and buttress laid in cement supports either end of the remaining wall.

The surviving early brickwork is formed in Flemish bond, an apparently very early use of the technique if the wall is considered to be closely contemporary with the construction of the Manor itself. The bricks are extremely dark purple/brown, almost black, but the dark colour of this section may have been exacerbated by the use of soot in the blackened mortar leaching from the faces of the brick. The facings of the lower third of the present wall height have been replaced (in a mix of yellow stocks and soft red bricks), likely due to accelerated decay caused by salt efflorescence wicked from ground moisture. The upper six courses to the brick-on-edge coping also appear to be later additions or repairs, now heavily covered in mosses and invasive flora suggesting the wall fabric is presently very damp. Any growth on these upper sections should be carefully removed and cracks or open joints pointed up in fresh lime mortar.

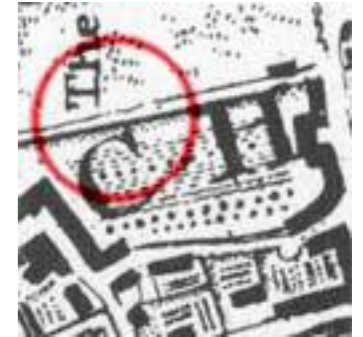
1.6.1 Mawson Lane/Griffin Brewery

This very long north boundary wall facing the A4 Great West Road runs from the early 20th century doorway, west to the junction with wall rebuilt in the 1930s following demolition of the western end of the site for road widening. This section of wall is listed grade II (HE list entry number 1294370). The full original length of the wall is clearly shown in Rocque's map (top right).

The wall generally consists of 28 to 30 courses up to the coping tiles, with the bottom 5-6 courses covered by a cement rendered plinth. The bonding and materials change going up the wall indicating a sequence of phases of construction and repair. Typically the lowest 15-18 courses are laid in English bond, with some mixing between header and stretch courses, either from repair or expediency during construction. The upper six courses are laid with a batter back in a gentle curve to the coping. Cast iron rainwater pipes have been cut into the wall and the brickwork either side reformed.

The bricks are mainly orange to dark red, with extensive pieced-in repairs in yellow stocks, some reversed stretchers or stained white from lime-bloom, though all are dirty. Sizes in the earlier phase vary from length 225-255mm, width 100-112mm and height 55-68mm. There is also a wide range of mortars, from soot-darkened lime to hard grey cement.

Externally, a clear pattern of water saturation and damp is visible, with subsequent salt efflorescences at the evaporation limit, and mosses on the wettest sections where failed joints in the gutters above have dripped rainwater onto the wall. The gutter junctions should be repaired to prevent ongoing saturation and deterioration of the wall below.

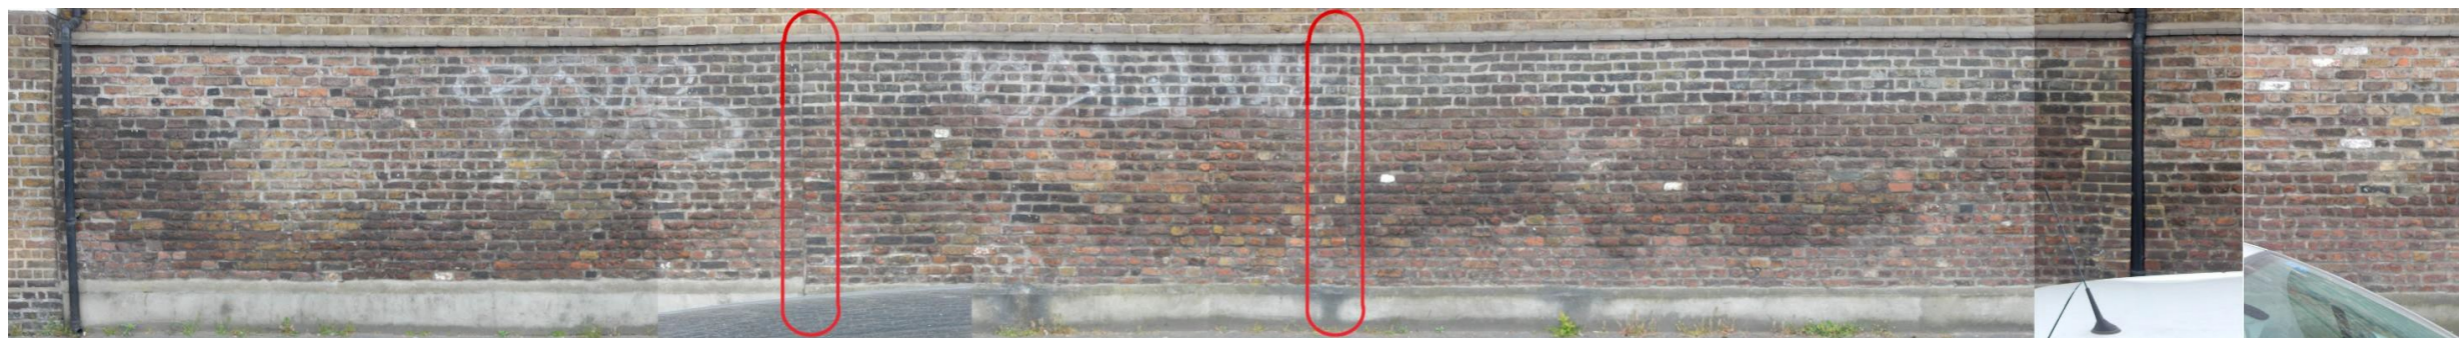
West central section

The west central section is the most interesting: in the photo survey the areas circled in red are straight vertical joints, made up to existing corners, and properly constructed with closers, thus indicating an earlier building upto which the walls were constructed. Although this is not shown in the Rocque map, this would suggest this section of wall was constructed pre-1746, and very possibly late 17th century.

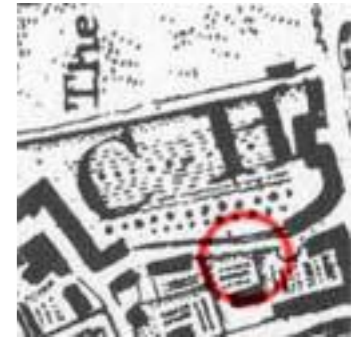
1.6.2 Griffin Brewery South boundary wall

A short, approximately five metre section of wall to the west of the stables offices is all that seems to remain of the boundary wall shown in Roque's map to the south of the road dividing the north and south brewery sites. Piers contiguous with this earliest section of wall form a doorway to what is now the cycle store. A substantial opening to the east of this has been infilled in late C20 brickwork with a cement mortar. Within the cycle store, the southernmost section of the east flank wall, though now painted, is of identical bond and construction, suggesting a pre-1700 date and matching the position of the N-S wall shown in Rocque's map (circled in map excerpt top right).

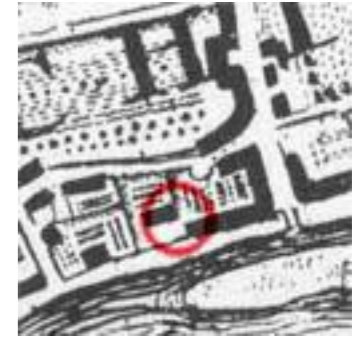
1.6.3 Wall East of Thames View House/Griffin Brewery

Only very short sections of this wall east of Thames View were accessible from the rear of the Griffin brewery Hock Cellars. The fairly random and mixed coursing and the composition of the bricks appears early, and the alignment would suggest that it is the southern end of the wall identified in the side of the Griffin brewery cycle store in 1.6.2 above.

Note the right side of the second image shows the jamb of a doorway. The inaccessible section is in poor condition and would benefit from consolidation with repointing in a soft lime mortar.

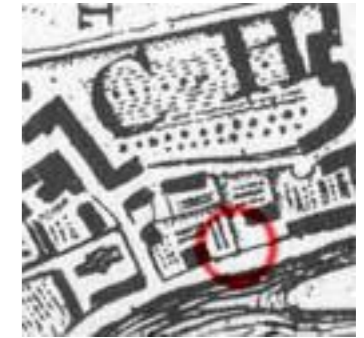
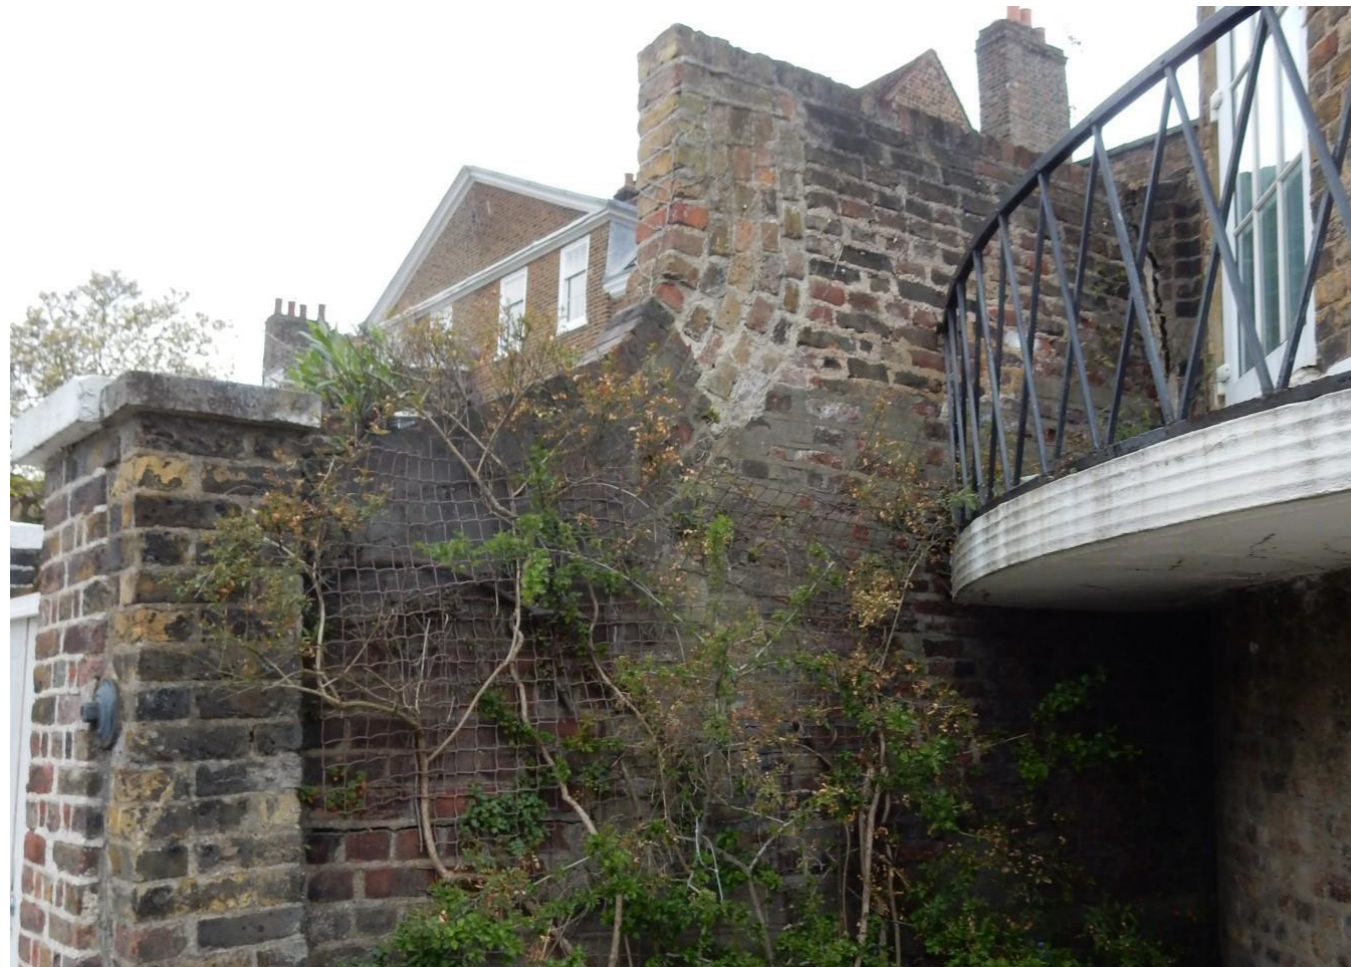
1.6.4 Said House/Eynham House

The southernmost portion of this wall is visible from Chiswick Mall. Here it can be seen that despite various phases of crude repointing with over-filled joints on both sides of this wall, and rebuilding of the upper sections, the soft red bricks, and mix of header and stretcher courses evident in the lower sections of this wall suggest this may be the south end of the long N-S boundary wall depicted by Rocque (see top right)

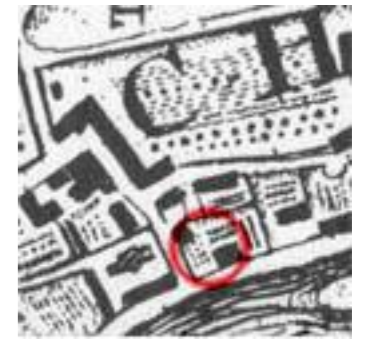
1.6.5 Woodroffe House/The Vicarage

The lower courses of the wall to the west of Woodroffe House (the west side shown below) show characteristics (soft dark red colour, and roughly English bonding) of the early 18th century or older, and may be remnants either of a boundary wall or of the building predating both Woodroffe and Bedford Houses that is shown in Rocque's map. The wall is listed with the house (HE list entry number 1294342)

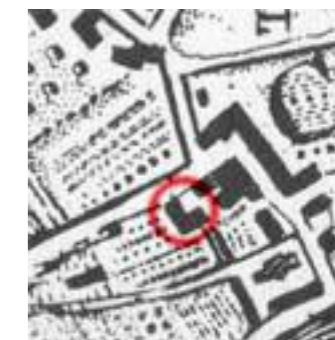
1.7.1 Chiswick Square

The wall running from the west side of Chiswick Square southwards to Boston House, consisting of soft dark red and purple bricks with 26 courses laid in English bond with a pale lime-rich mortar. The southern arch opening is a later 19th or 20th century addition. The wall certainly predates the construction of Boston house, and its material and form also suggests a date earlier than the houses to the front of Chiswick Square, constructed in the 1690s. The wall does not presently appear to be listed in its own right.

Apart from some areas of damp to the south and minor invasive flora the wall appears to be in good condition.

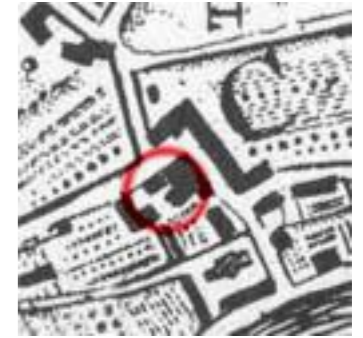
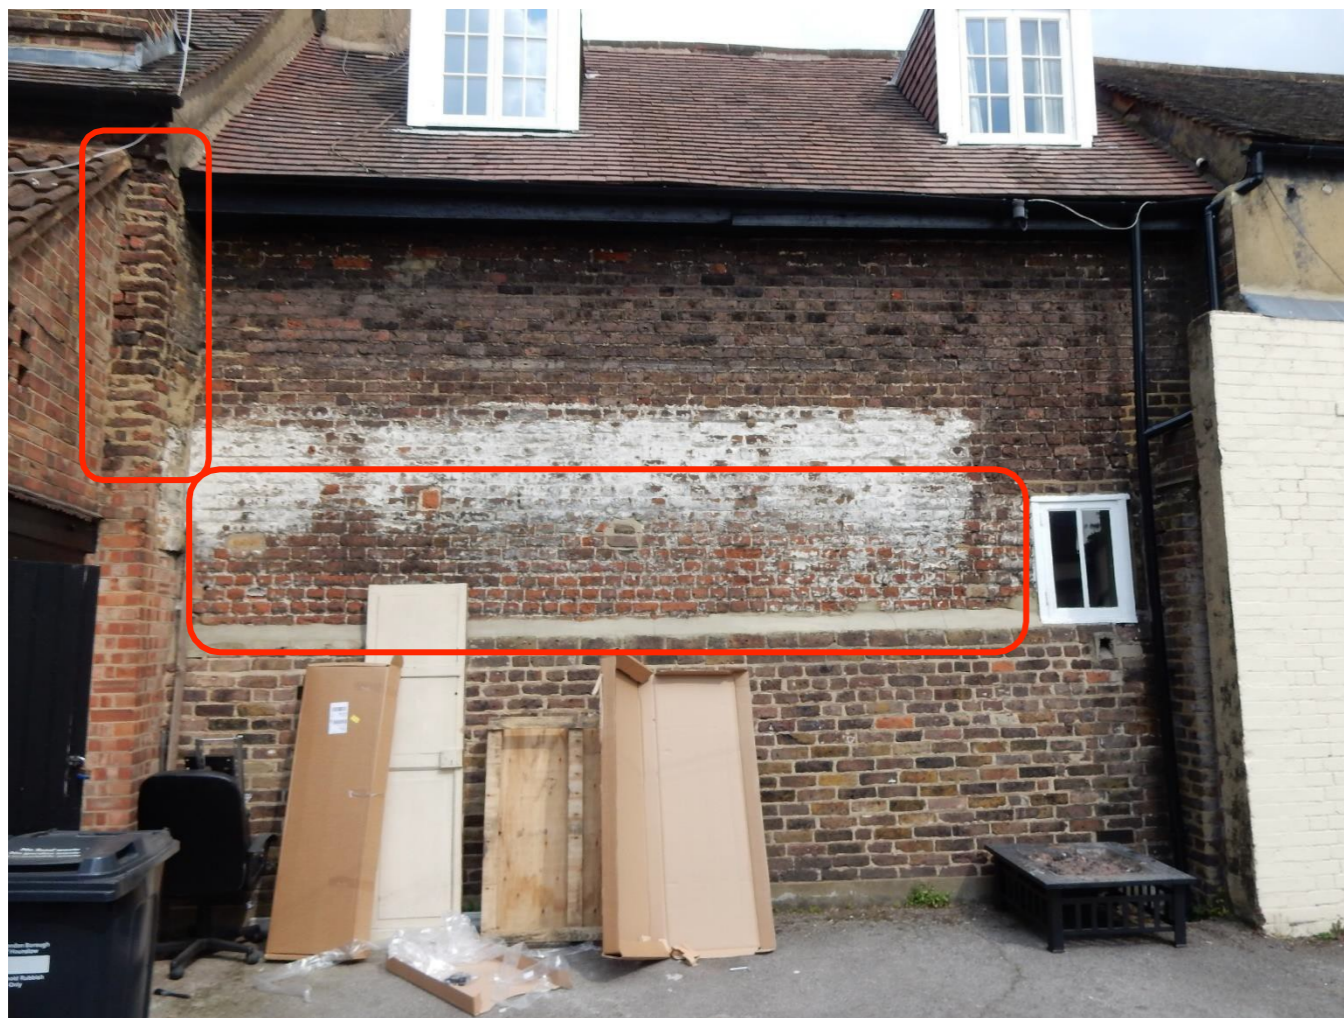
1.7.2 Walls incorporated into the rear of the houses of Page's Yard

The back, west-facing wall of one of the houses on Pages Yard, visible from the beer garden of the George and Devonshire, shows a clear series of header courses in soft red brick (below the dark brown of the upper walls, and above a lower section of stretcher courses of 19th or 20th century construction) suggesting that this row of cottages may have been constructed over an existing boundary wall or earlier building in the 18th century. The upper half of the corner of the building to the N (LHS of image) also appears much earlier than surrounding brickwork, and does not course though with it, suggesting a possible pre-1700 date for this building.

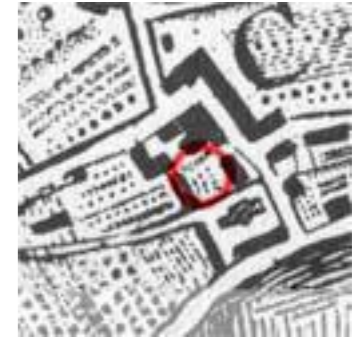
1.7.3 Latimer House

Of all the walls inspected, that to the north of the garden of Latimer House was immediately identifiable as pre-1700, with a clearly read English bond though the full length of the wall. The wall is listed (HE list entry number 10803555), but is illustrated and discussed here for reference and comparison with the other unlisted or unrecorded walls. It is worth noting that this wall is not illustrated in Rocque's map. Latimer House and Holly House were divided into separate dwellings in the early 19th century.

The walls facing into the passage have been extensively repaired and repointed, much using cementitious mortar, hampering dating analysis of the brick, but the elevation east into the garden of Holly House comprises soft darkened reds laid in an erratic Flemish bond, possibly of the early 18th century.

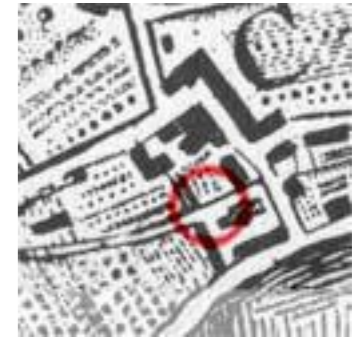
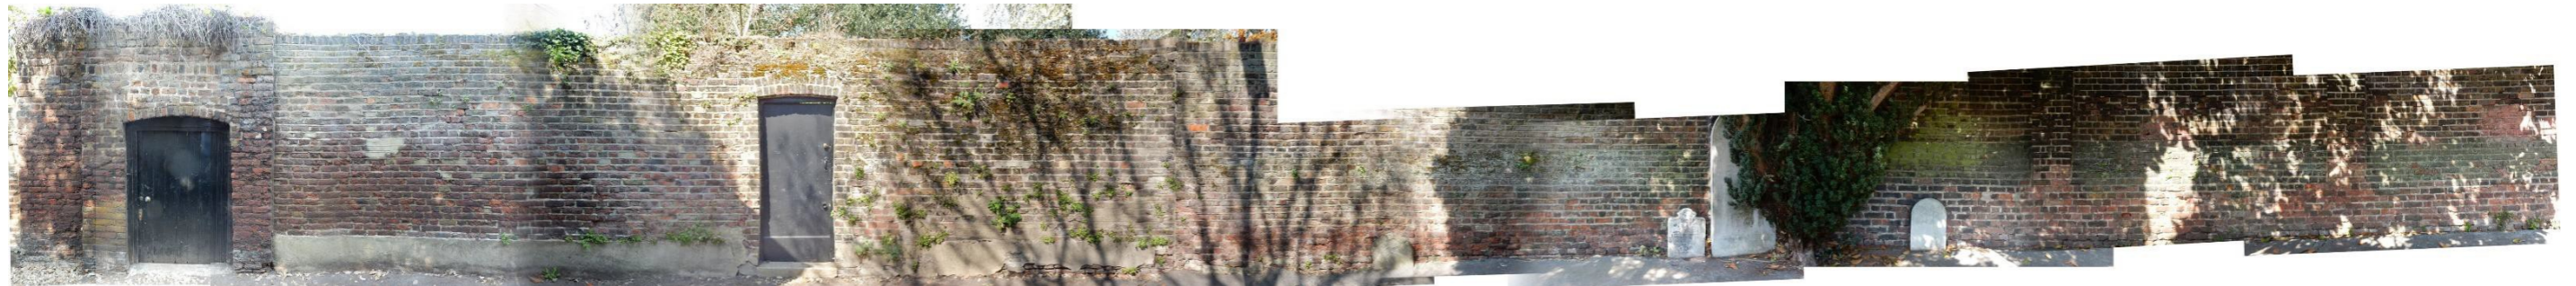
1.7.4 Powell's Walk/Holly House

From the easternmost end of Powell's Walk, eastward: A projecting low-arched doorway, early, with approximately 2½ feet of contemporary wall W of this, both 31 courses up to a brick on edge coping, with two additional courses slightly later, extended with a further four courses of modern yellow brick, all in Flemish bond, although the pattern and alignment is erratic, and the lowest 6 courses obscured by a cement-rendered plinth. The main walling brick varying in dimensions from 220-225mm length, 98-100mm width and 60-63mm height. The arch is formed of 17 headers on edge, with approximately 3" of arch camber, supported by a heavy timber lintel and stiles. Numerous repairs, brick replacement, and repointing in both cement and lime have been carried out, and the lower twelve courses of the left pier refaced in C20 yellow/orange bricks 225x65x103mm, and tile inserts over the arch. The original bricks are dark red to purple in colour, though orange where faces have spalled, and their form is heavily creased, and the material soft. The earliest mortar is sooty with a coarse aggregate. Heading eastwards,

a later doorway has been inserted, and the change in colour of this section of wall, more erratic brick bond, and a straight joint further east suggest this section may have been rebuilt at a later date, though still perhaps eighteenth century, with properly constructed corners with closers up to the straight joint. This section of wall is in poor condition, with extensive vegetative growth, smeared cement repairs over spalled faces, and a pronounced deformation.

Further east, the abutting wall does not course through, and at least in the bottom half, appears earlier, both from the softer and darker brick, and the use of English bond in the lower 12 courses. The upper section appears to have been rebuilt or extended, with 8 battered courses supporting a further 14 plumb courses to the coping. The upper sections are reinforced with a series of buttresses (the first concealed by a mature yew tree), after which less of the earlier wall appears to survive, and a more regular Flemish pattern is observed lower in the wall, extending to the full height of it towards the formation of the nineteenth century opening into the side of Holly House. Despite very crude cement repointing across the western end of this wall, the erratic coursing suggests that the inner face of the lower portions of this wall may predate the outer. The buttresses and piers further east also support the notion that this central section may have been rebuilt. Beyond this to the east the dark soft red bricks and English bonding of the lower half suggest an early of late 17th to early 18th century date having been extended. Most of the lower sections of this wall appear very damp, the lower third white with salts.
