Old Chiswick Conservation Area

Historic Walls Survey, Analysis and Conservation Advice

For The Old Chiswick Protection Society

September 2021

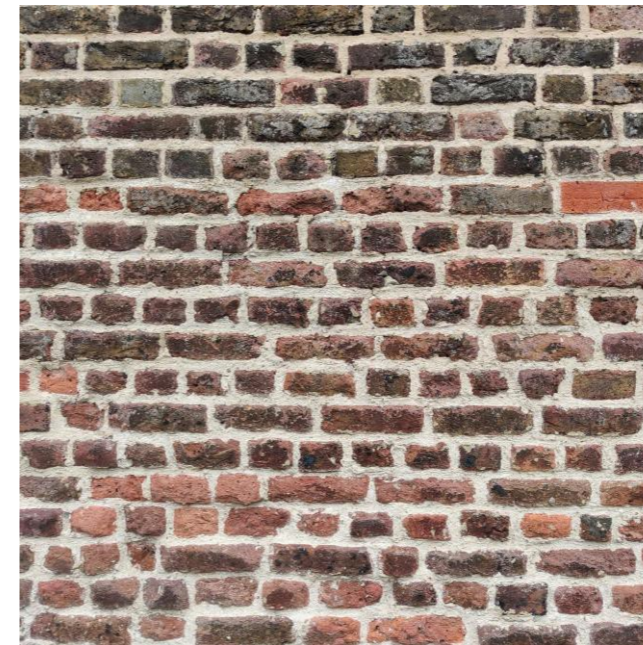
An example at the boundary walls of Ham House of correctly flushed back lime pointing, avoiding overfilling to the spalled faces of old bricks
